## Prague-Kunratice, Prague

Medieval castle 'Nový hrad' u Kunratic and siege camp (15th cent.)

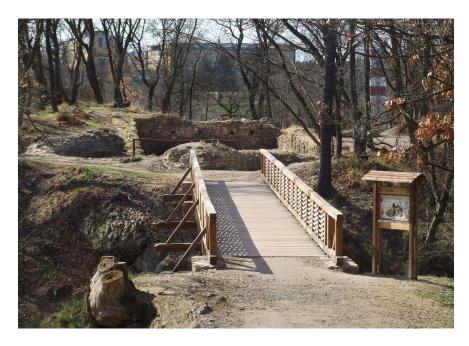
Castle core with a cellar of the tower-like palace. View from north-east, across the moat. Photo J. Hložek, 2014.

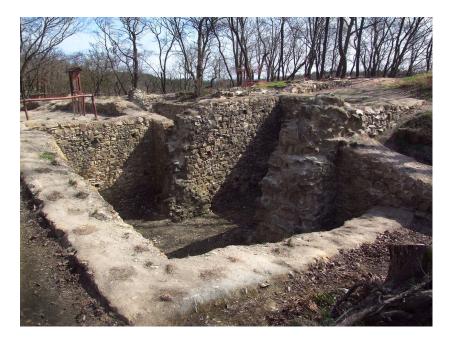
Second gate with a walled-in moat.

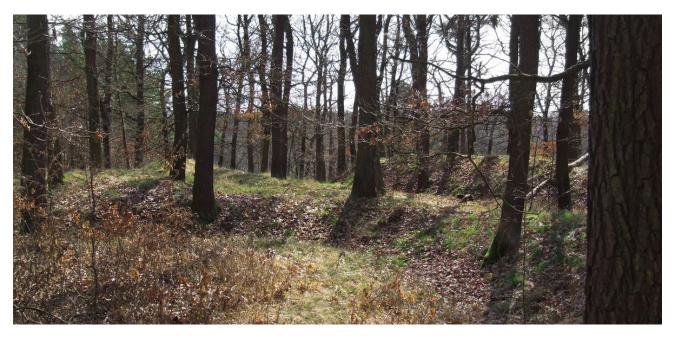
Northeastern fortification of the siege camp.

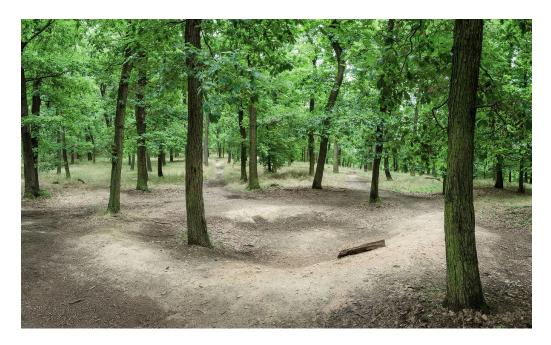
Surface relicts of buildings belonging to the siege camp.

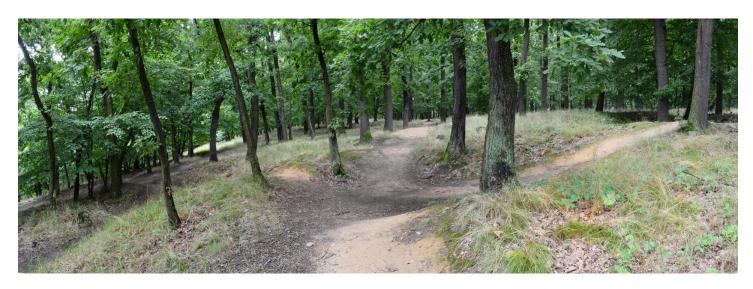
Built-up area of the siege camp.
