Senorady, Brno-Country dist., Southern Moravia Region

Medieval castle Šance

(probably from the 14th cent. to the beginning of the 15th cent.)

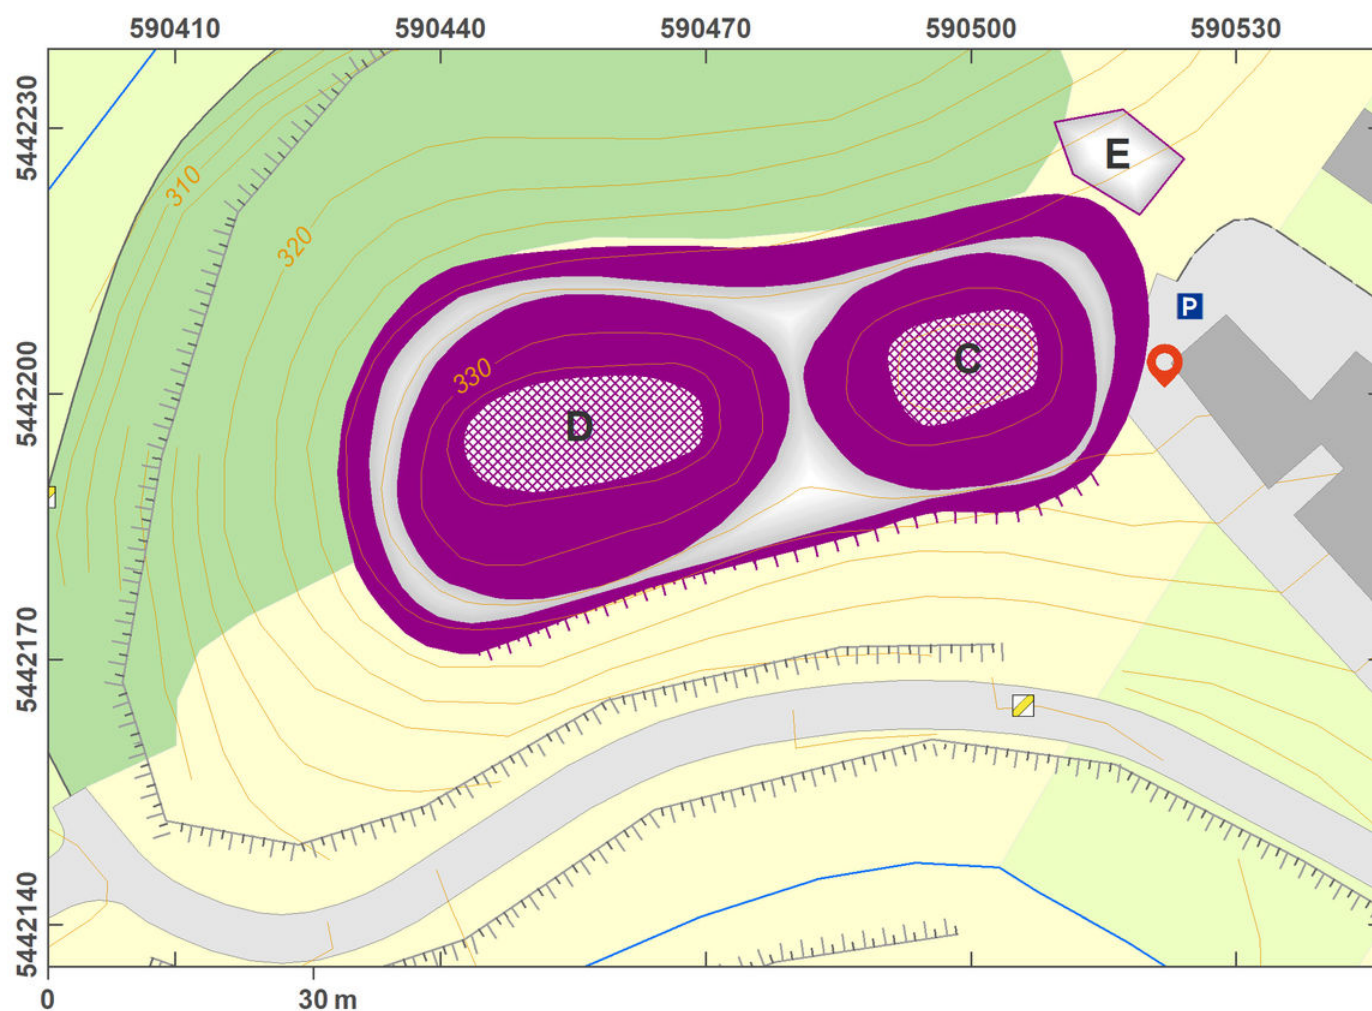
Site plan.

Map notes: A – ditch; B – earthwork; C – smaller mound in the eastern part of the castle; D – larger mound in the western part of the castle; E – remains of the outer ditch.

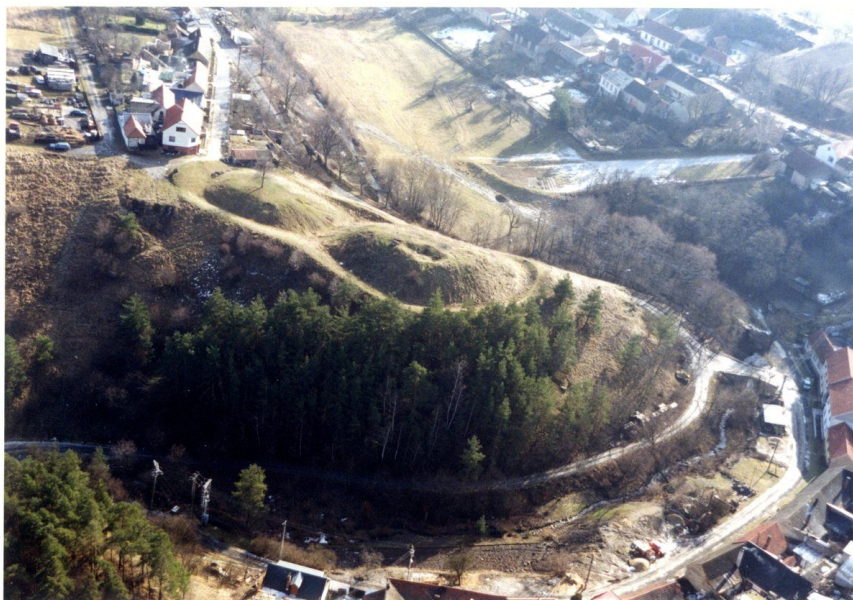
Aerial view of the small castle with well visible relics of the neck ditch.
