Malšice, Tábor, South Bohemian Region

Medieval castle 'Příběnice'

(13th–15th cent.)

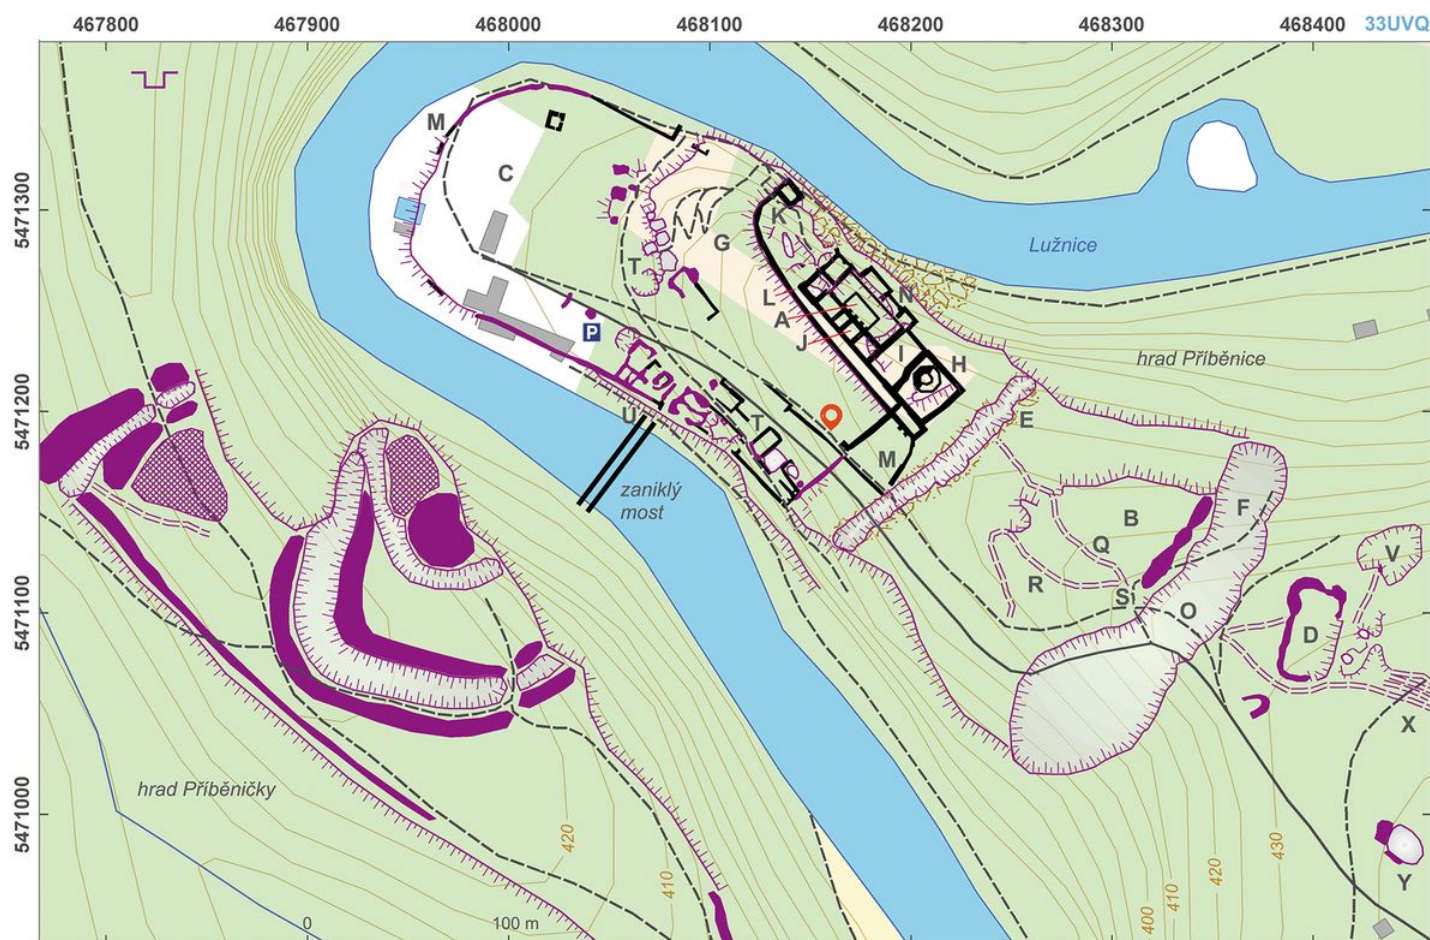
Site plan.

After Kuna et al. 2014.

Map notes: A – castle central area; B – bailey; C – 'latrán' (suburb); D – siege camp; E – ditch between the castle and the bailey; F – ditch between the bailey and the castle foregrounds; G – path from the suburb to the castle; H – keep; I – courtyard; J – palace complex; K – square tower; L – corridor between first courtyard and the palace; M – suburb fortifications; N – Zwinger ('parkán' in Czech, zone between two lines of defensive walls) with two bastion-like features; O – passage over the ditch; Q – path through the bailey towards the castle; R – path to the suburb; S – location of the first gate; T – remains of buildings within the suburb; U – bridge foundations; V – siege fortifications; X – hollow ways; Y – deserted manorial farm.

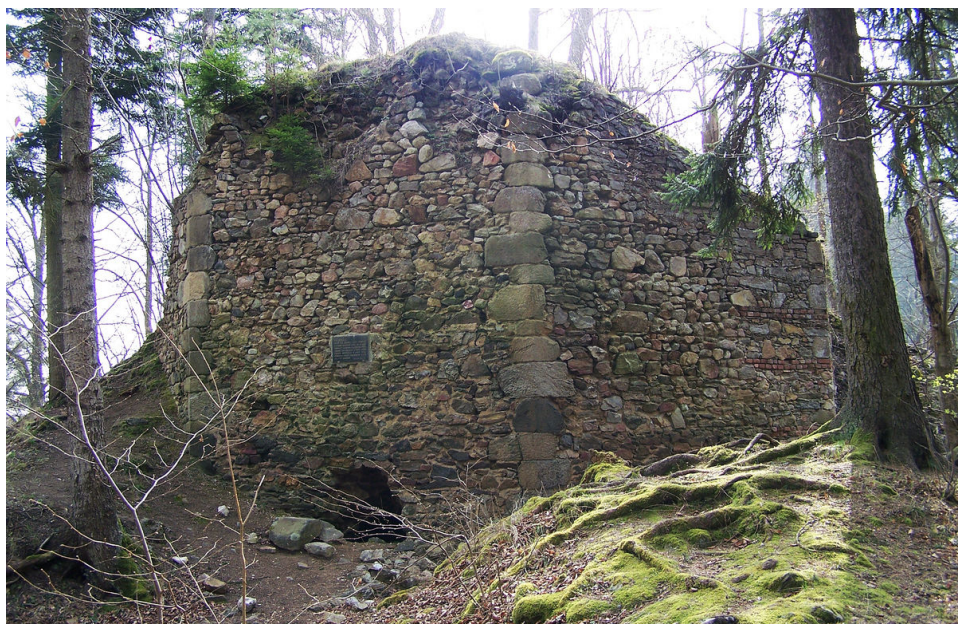
Remains of a bergfrit.

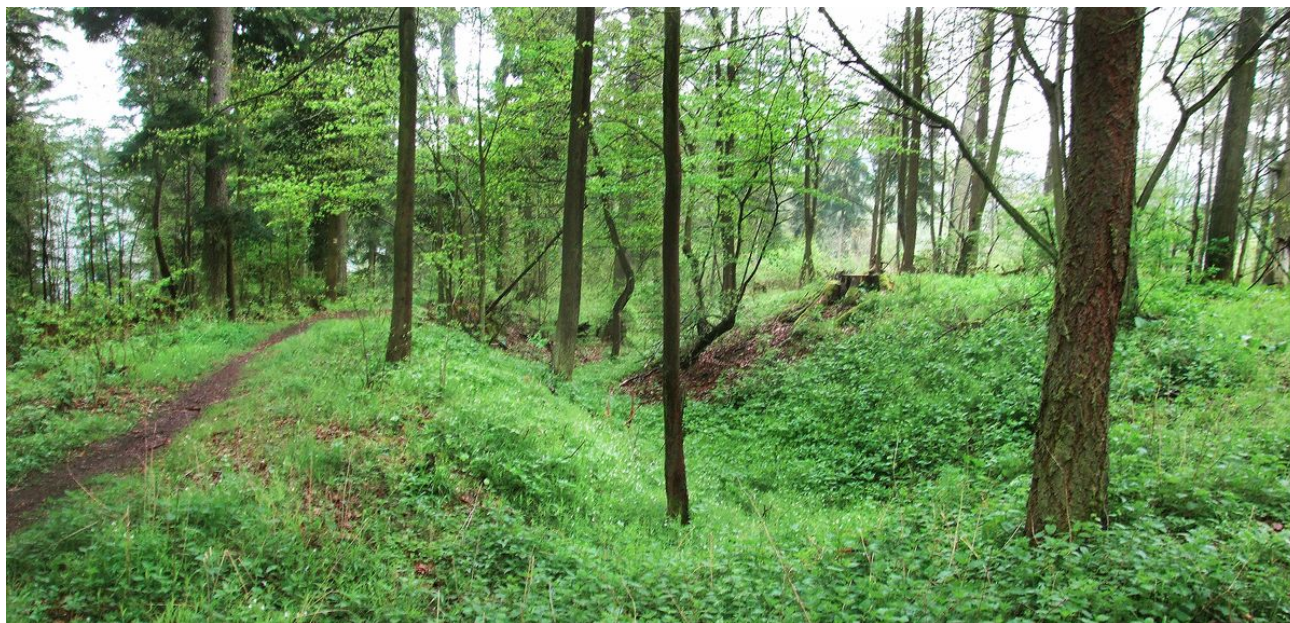
A hollow way leading from the first gateway to the castle's core.

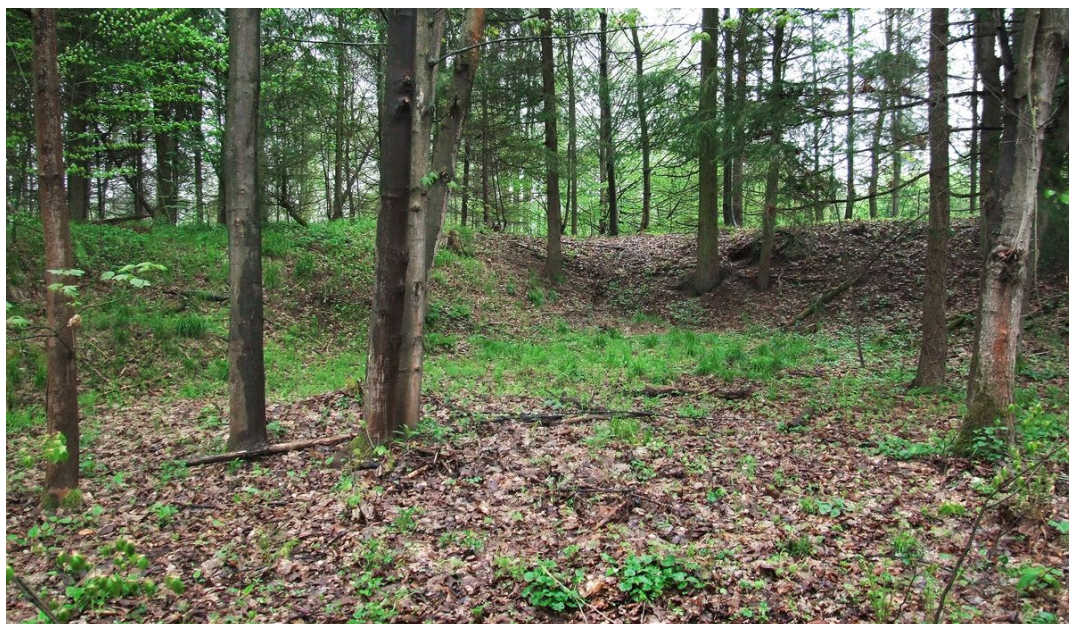
Traces of siege works in the castle's foreground.

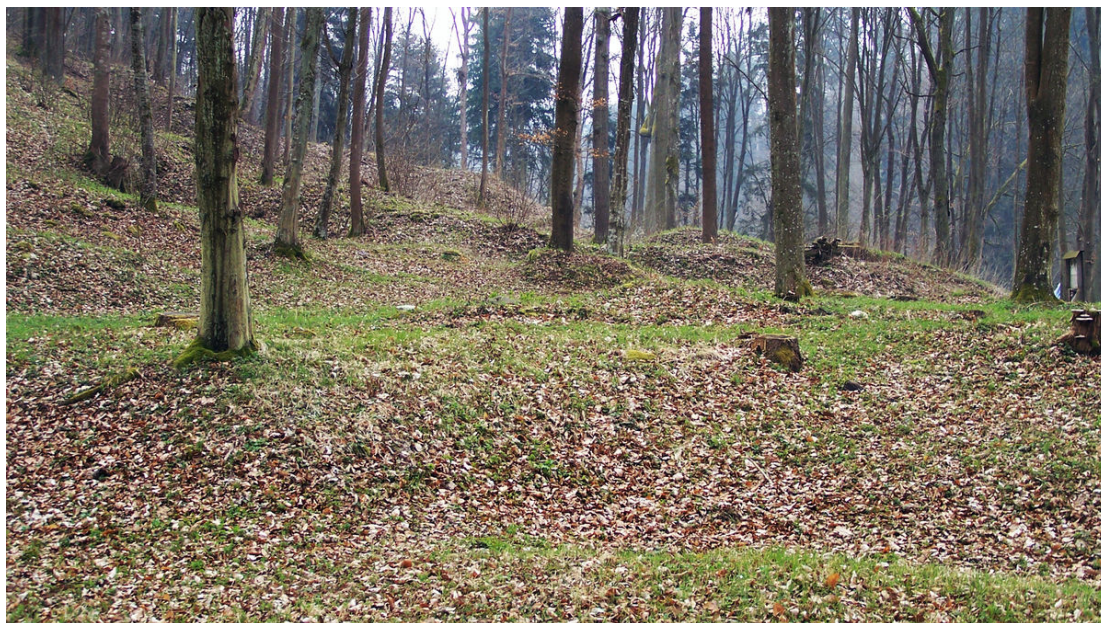
Bailey with a deserted hollow way.
