Pořešín, Český Krumlov dist., South Bohemian Region

Medieval castle

(13th–15th cent.)

Extensive ruins of the Castle of Pořešín, with adjacent areas of a production character. Built at the end of the 13th century, the castle enjoyed its heyday and greatest reconstruction under Markvart I in the second half of the 14th century. In the first half of the 15th century, the castle was damaged and burned by Oldřich of Rosenberg (Rožmberk), an event that remains evident in the masonry to this day. The castle was originally dominated by a keep; later construction was concentrated around the curtain wall, despite the fact that the keep was still standing. Preserved in the vicinity of the castle are a millrace, stone quarries and a limestone kiln.

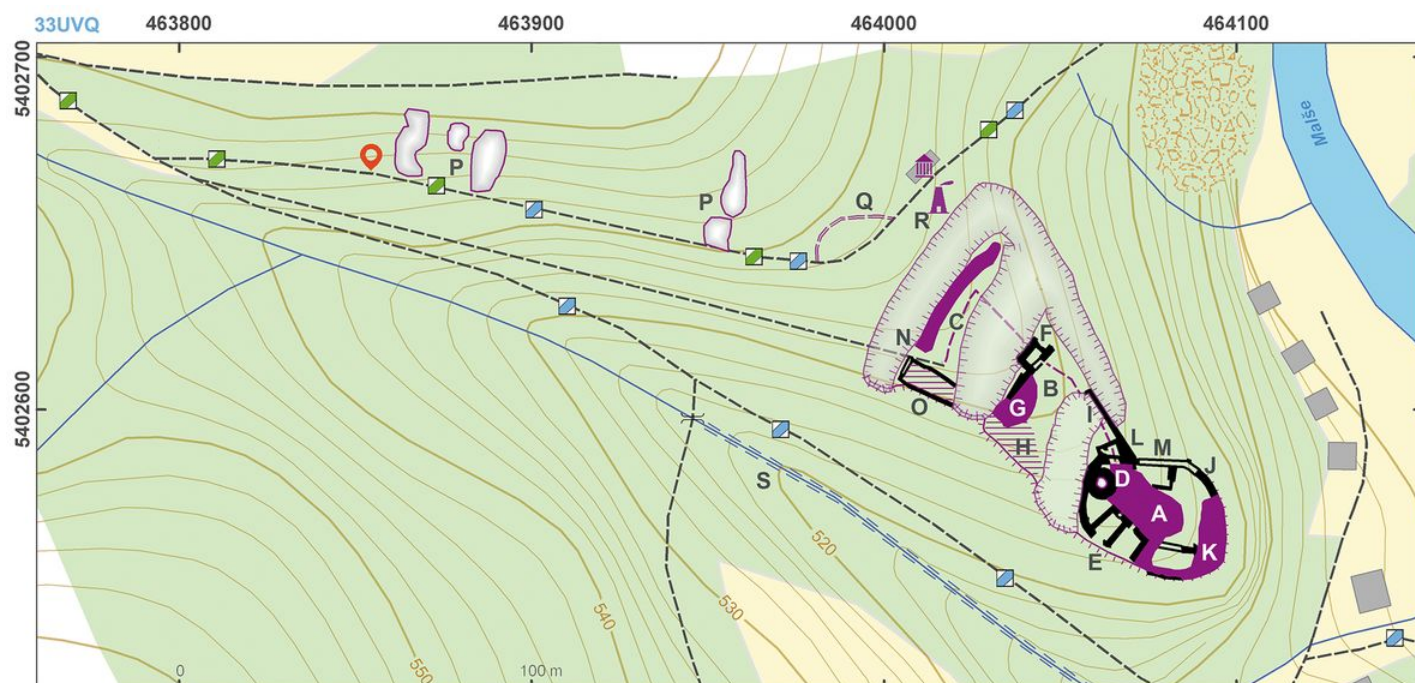
Site plan.

Map notes: A – castle; B–C – baileys; D – keep; E – two-compartment palace; F – tower gateway; G – remnant of stone structure; H – platforms left after above-ground structures; I – mouth of the third ditch, later protected by a wall; J – defensive wall around the centre of the castle; K – buildings attached to the wall; L – third gate; M – kitchen; N – stone bridge support; O – building, the upper floor of which was insulated by a wattle construction; P – quarries for building stone; Q – hollow ways; R – remains of a limestone kiln; S – remains of a millrace.

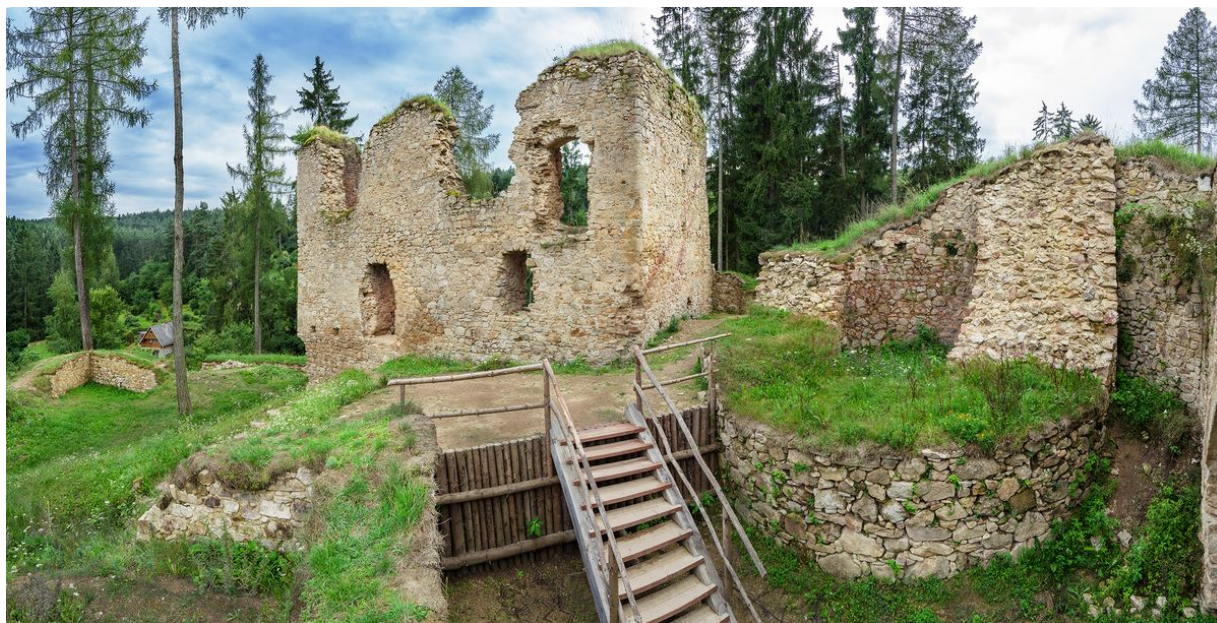
Castle core from north. Wall of the earliest castle palace, ruin of a bergfrit (right).

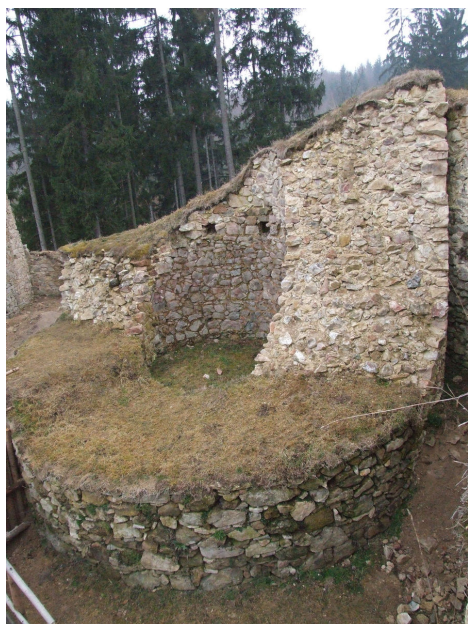
Remains of a bergfrit.

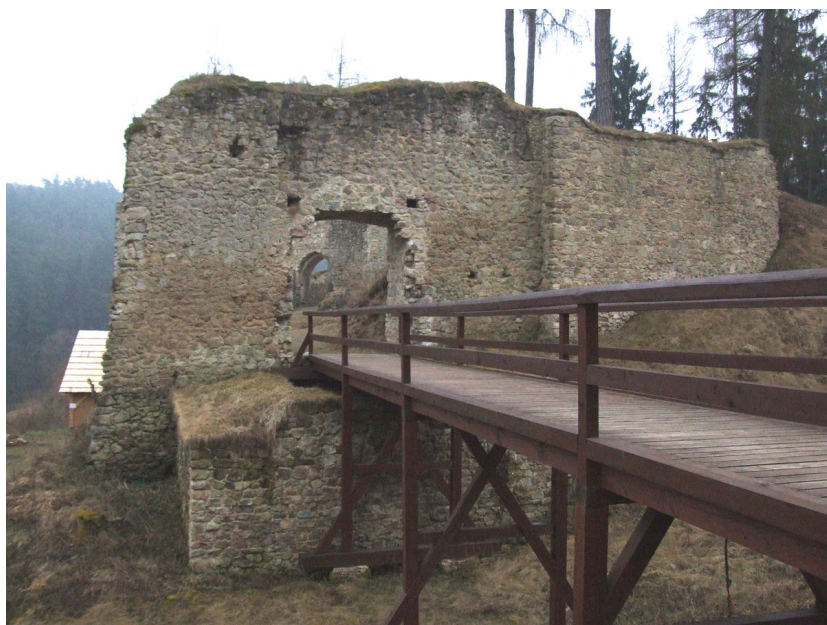
Second gate.

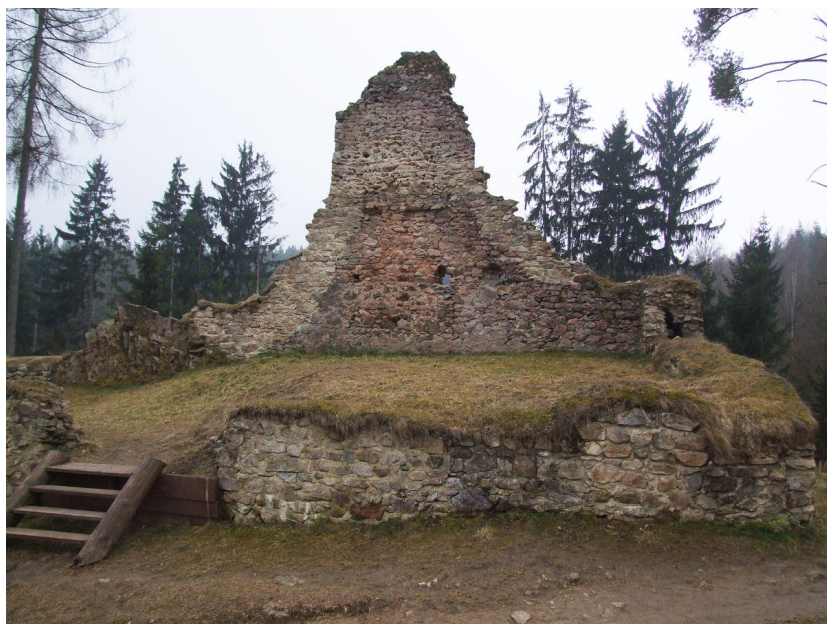
Otisk zateplené komory v prvním patře budovy na prvním předhradí.
Foto J. Hložek, 2006.

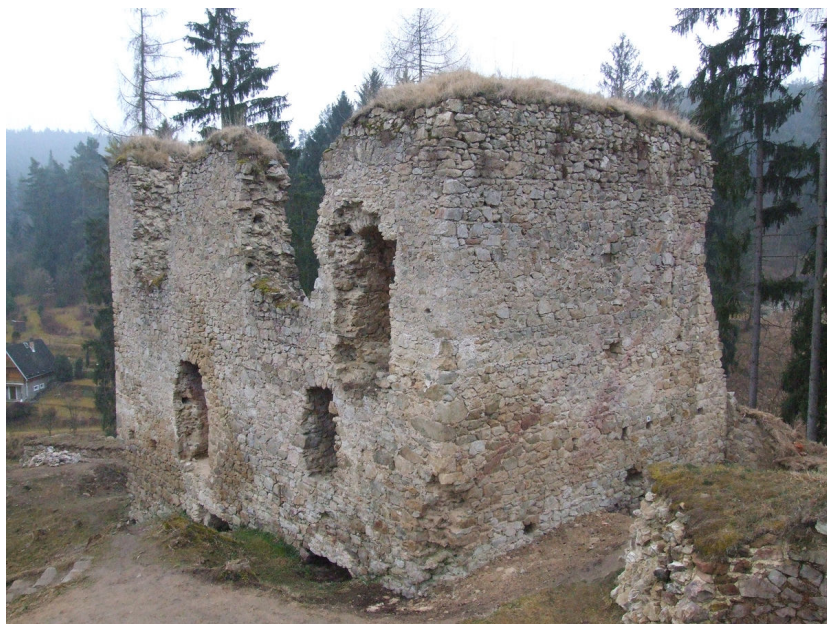
Probably the earliest palace of the castle core.
