Žabčice, Brno-Country dist., Southern Moravia Region

Medieval fortified manor and village

(from the mid-13th cent. to the beginning of the 15th cent.)

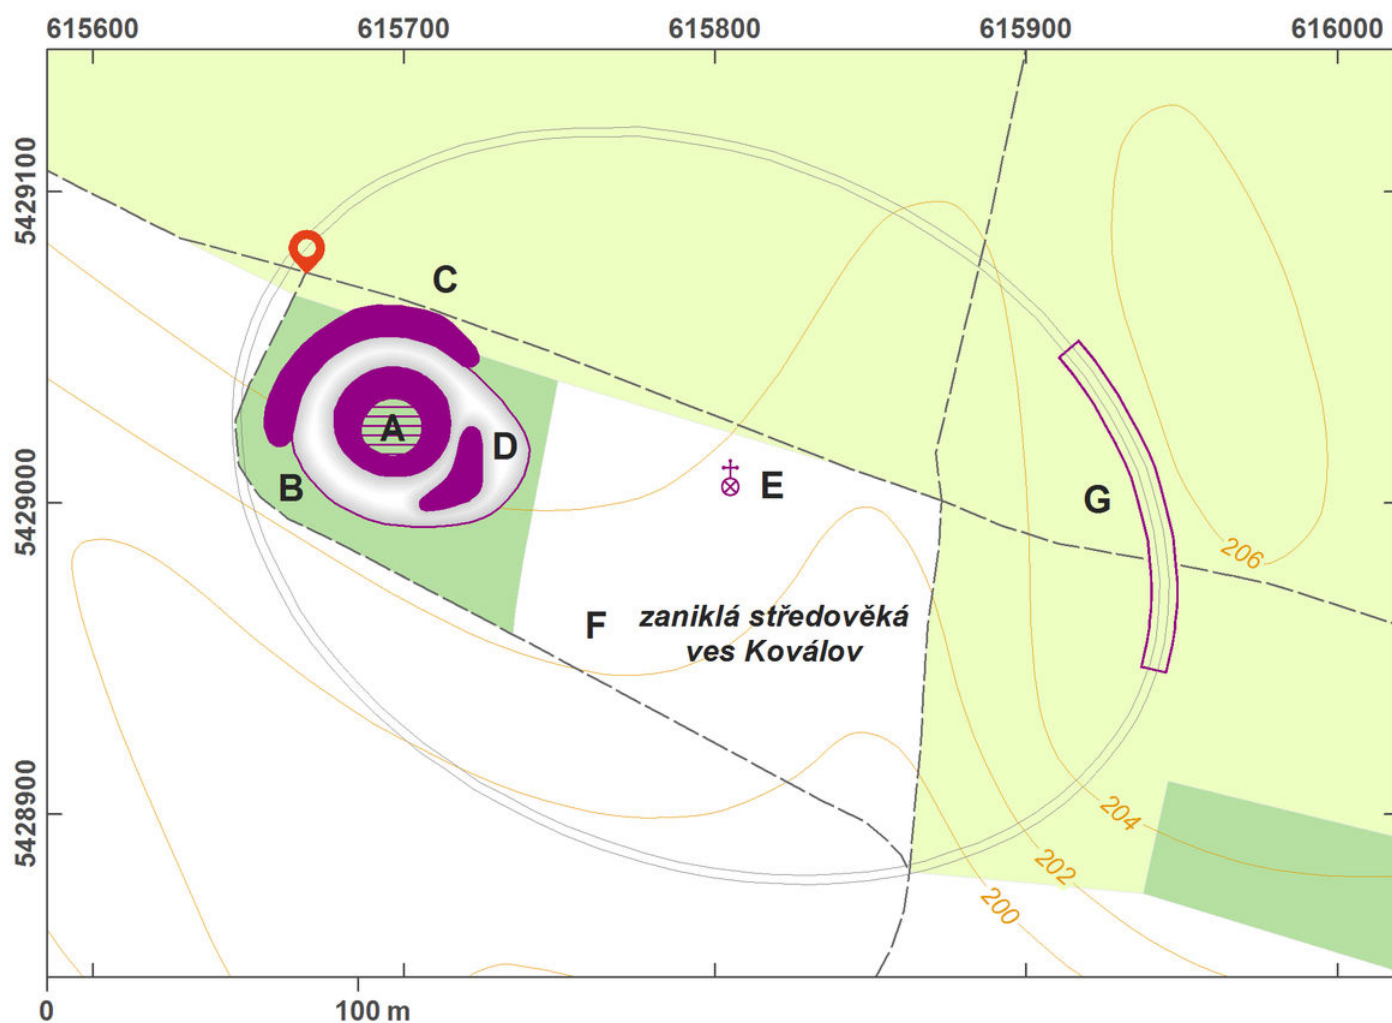
Site plan.

Map notes: A – hill in the shape of a truncated cone; B – ditch; C – earthwork; D – church; E – village; F – possible enclosure of the village.

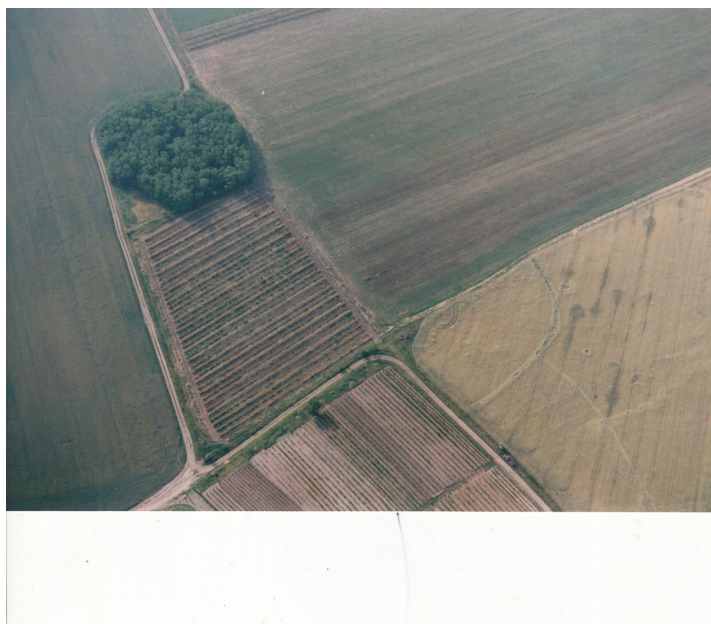
Aerial view of the deserted village of Koválov and the overgrown motte of Kulatý kopec.

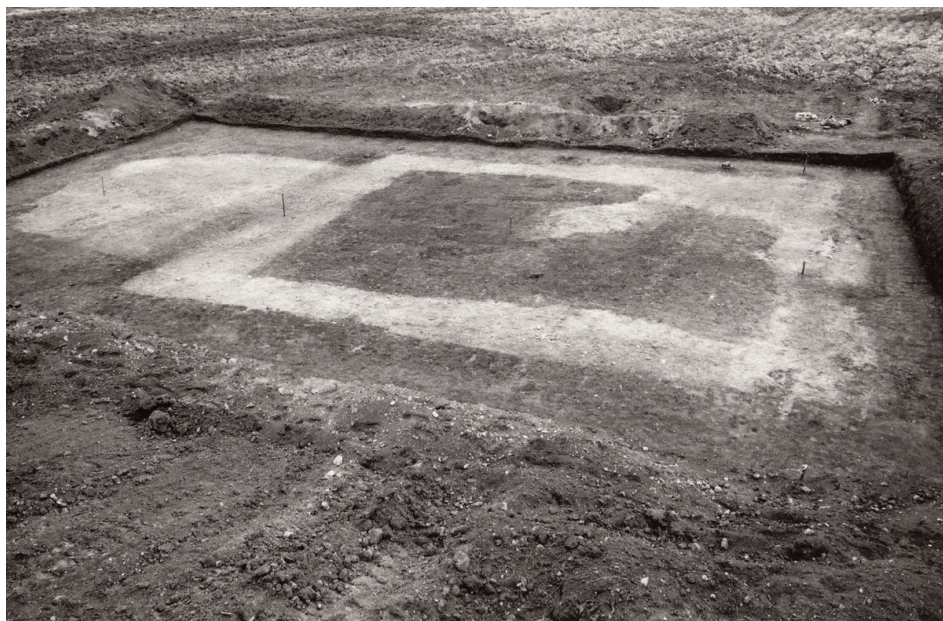
Ground plan of the church on the uncovered surface.
