Zlaté Hory in Jeseníky, Jeseník dist., Olomouc Region

Medieval castle Edelštejn

(13th–15th cent.)

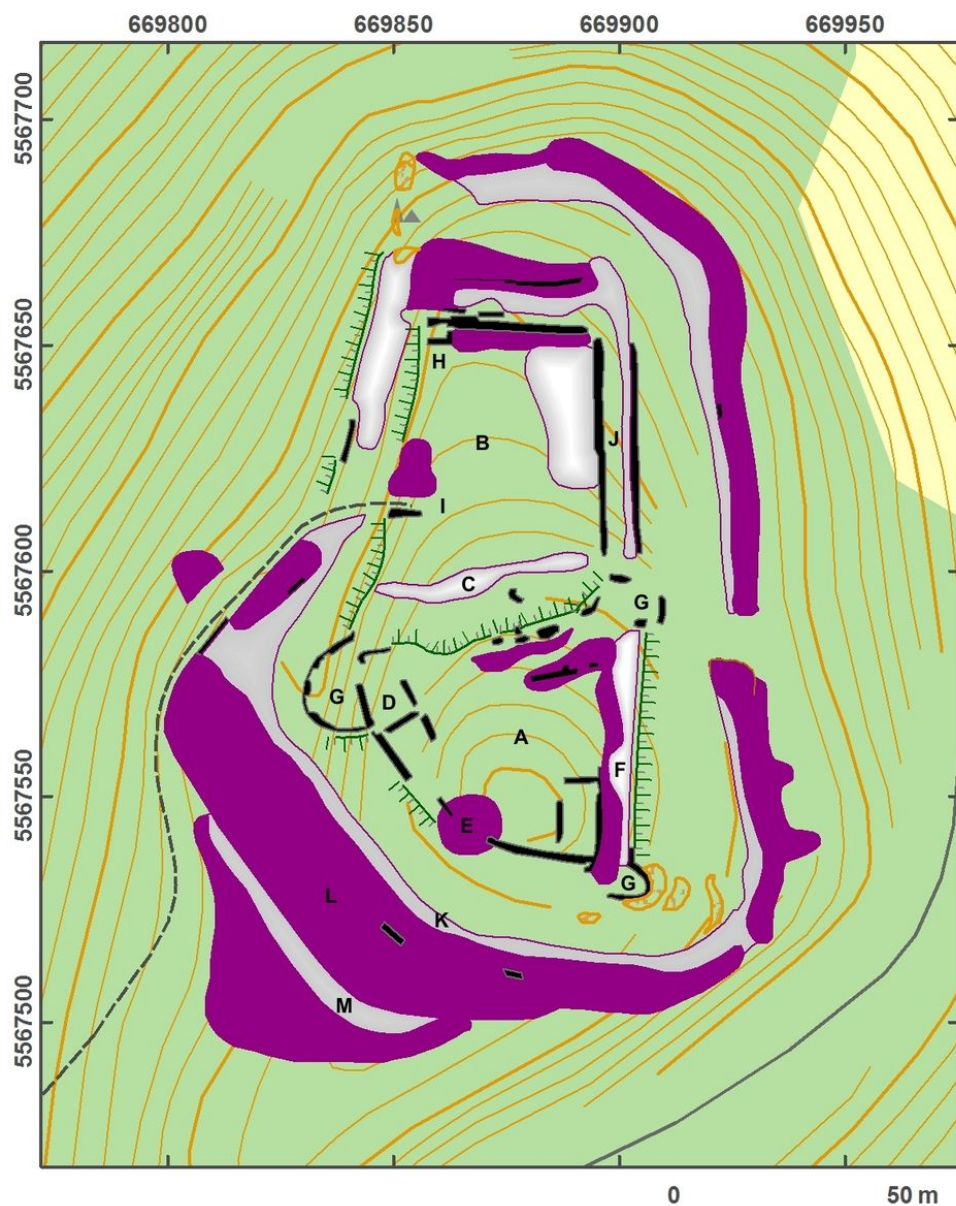
Site plan.

Map notes: A – upper ward; B – lower ward; C – ditch; D – remains of buildings in the castle corner; E – bergfried; F – zwinger wall; G – corner bastions; H – fragments of a corner tower; I – remains of a gateway; J – zwinger; K – ditch; L – earthwork; M – neck ditch.

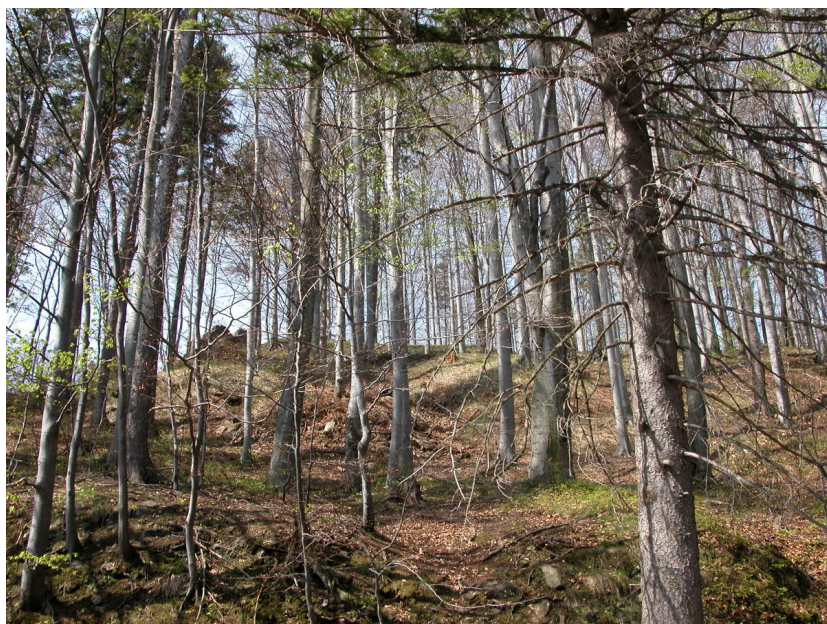
Bastion of the south court of the upper ward, view from the north-east.
Photo H. Dehnerová.
